# RESEARCH MEMORANDUM

PRELIMINARY INVESTIGATION IN J33 TURBOJET ENGINE OF SEVERAL  
ROOT DESIGNS FOR CERAMAL TURBINE BLADES

NATIONAL ADVISORY COMMITTEE  
FOR AERONAUTICS

January 26, 1953

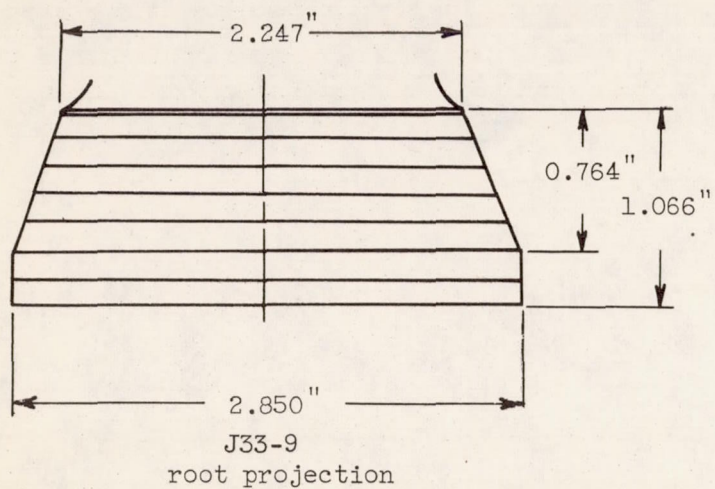
Figure 1. - Projections of J33-A-9 and J33-A-33 turbine roots.

Root design. - In changing from the J33-A-9 to the J33-A-33 engine the root profile was kept the same but the width was reduced (fig. 1). For the standard fir-tree-type root, this change plus the slight increase in blade length resulted in an increase in the stress across the top serration of from 8900 pounds per square inch to 11,400 pounds per square inch at rated speed for a ceramal blade having a reported density of 6.0 grams per millileter.

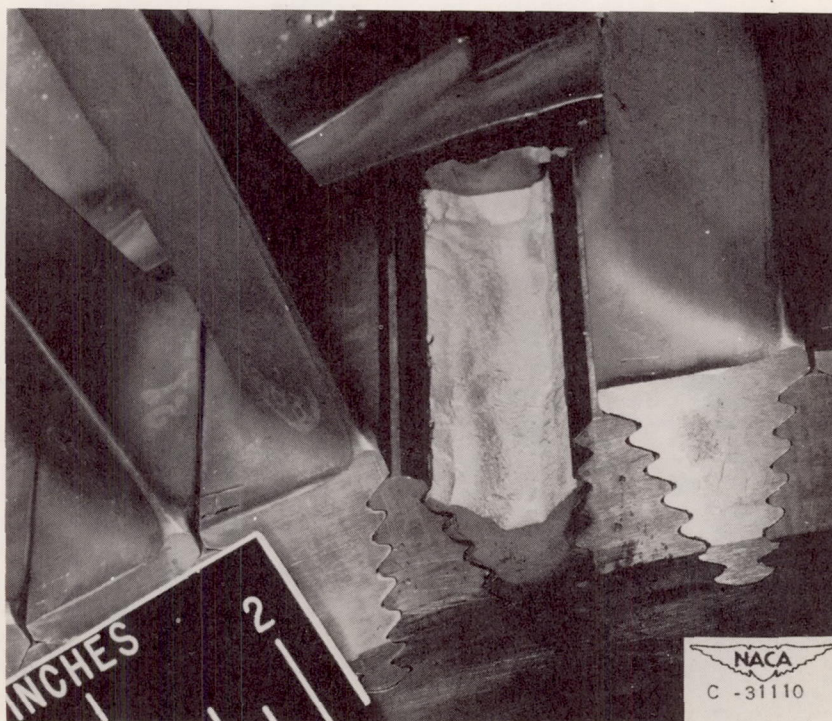
not appear so sound as the blade used in run 4. Figures 3 and 4 indicate the type of failures encountered with this type of root.

Figure 4. - Failure of ceramal blades having fir-tree root after 2 hours and 23 minutes of operation. Failure occurred at 9000 rpm.
